# OLD BURYING GROUND & TOMBS AT MOUNT PLEASANT CEMETERY PRESERVATION PLAN

ARLINGTON, MASSACHUSETTS 2018

**NOVEMBER 2018**

**RAY DUNETZ LANDSCAPE ARCHITECTURE, INC.**

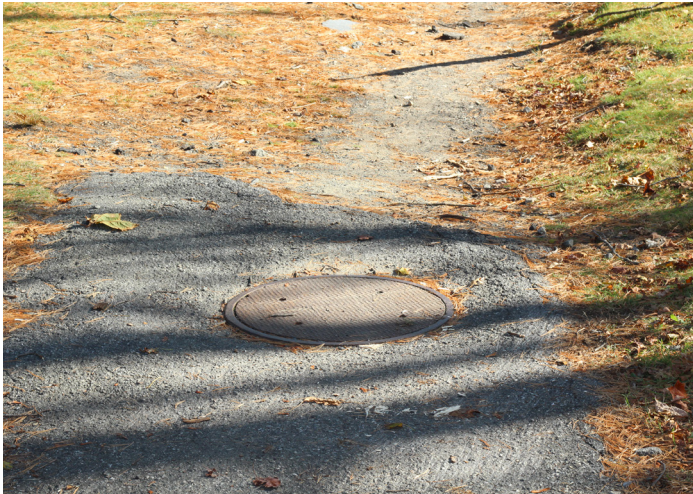
3. Bituminous path

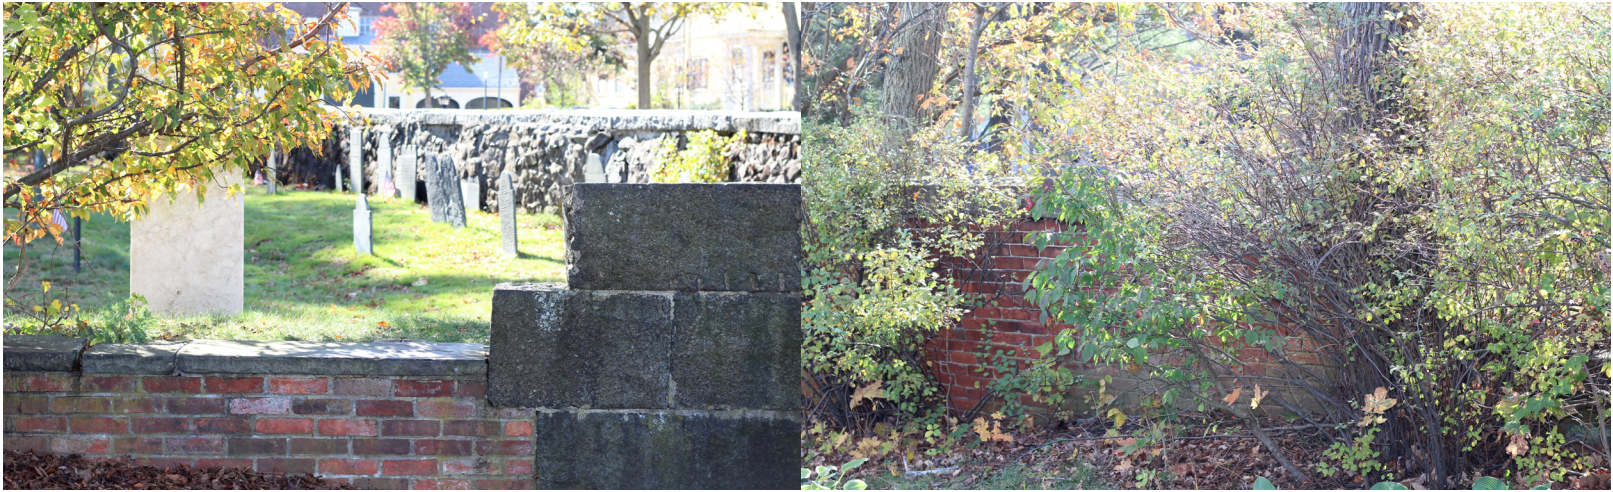
7. Northeast wall - brick

Dismantle unstable brick portions of wall and rebuild using salvaged brick and salvaged granite coping stones. Reset marble plaques in their original position. Wall work adjacent to tombs to follow recommendations per the 'Addendum to 2018 Arlington's Burying Ground Tomb Assessment Report' located in the Appendix.

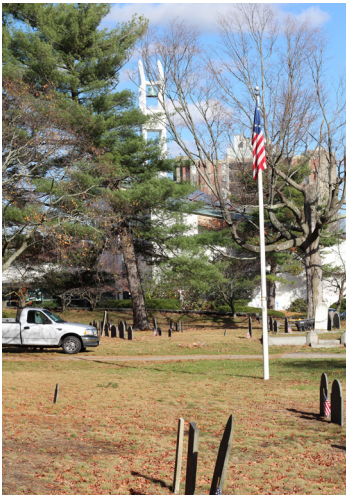
One unlit white painted flagpole at 25' height is located near the main entrance. The history of its installation is unknown, but appears to be operational and in good condition.

14. Flagpole

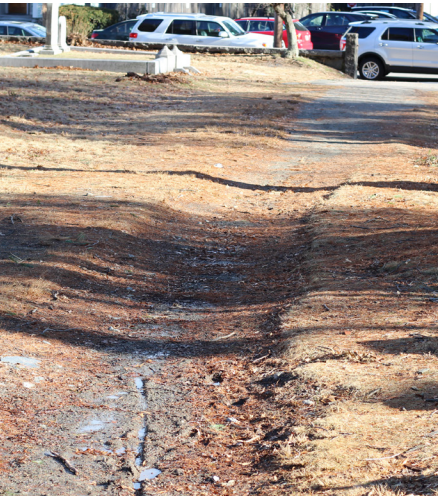
15. Low area

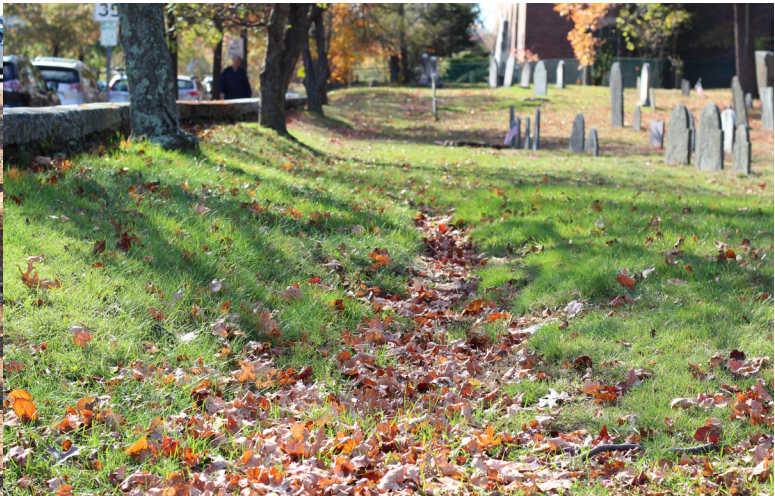
Findings revealed that the primary issue for the poor turf conditions at the OBG is lack of maintenance. pH levels are very low which reduces nutrient uptake and availability of nutrients. Bare ground areas have not been re-seeded and soil fertility is low. Thatch has reduced the ability for root penetration and the grades allow for ponding of water. In addition, the lawn appears to be in shade for many hours of the day.

16. Bare lawn

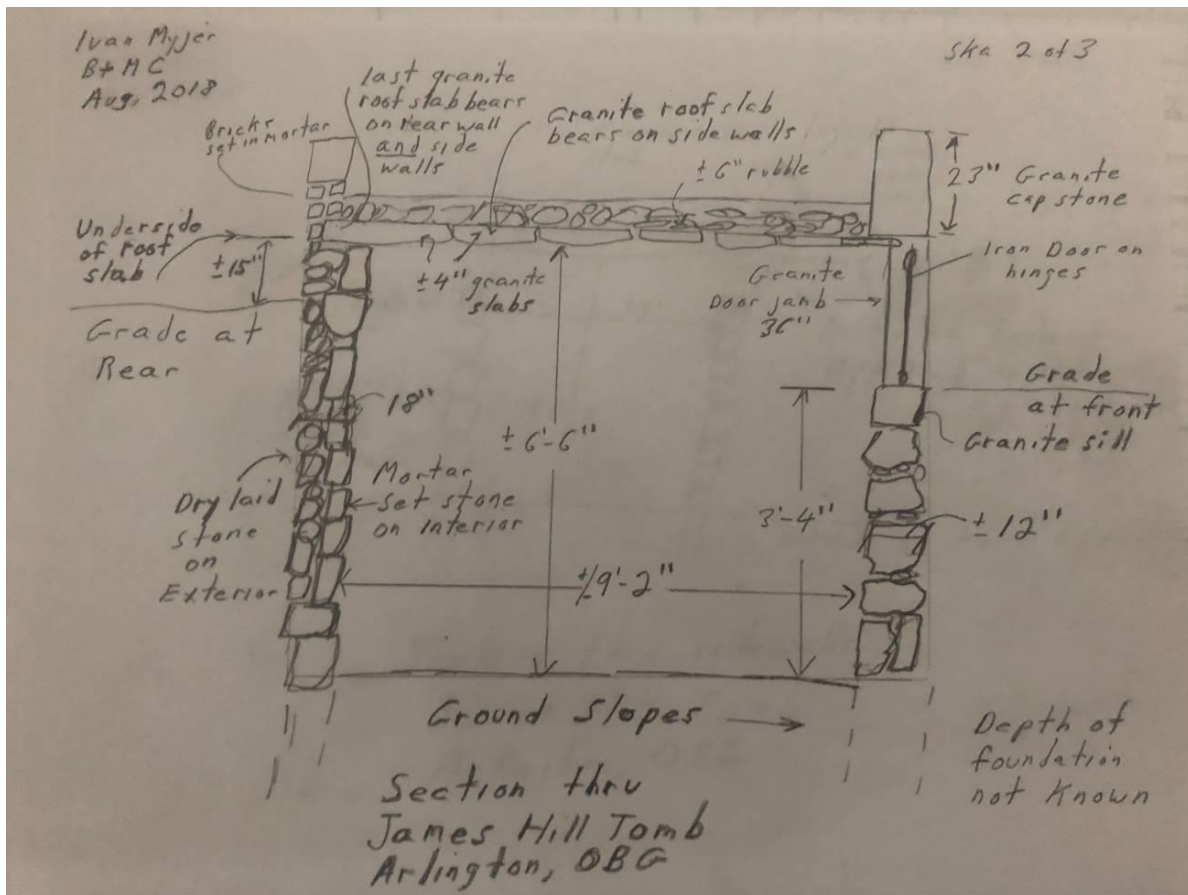
Ska 2 above shows that the perimeter wall and the structural walls of the tomb are joined. The structural walls of the tomb however were laid in mortar while the perimeter walls of the OBG were not. This distinction should make it very easy to determine where the perimeter wall ends and the structural walls begin during the disassembly of the perimeter walls. The 15-inch measurement shown above from the underside of the roof slab to the height of the soil on the rear wall defines the zone of the rear of the tombs that might be impacted by the disassembly and rebuilding of the west perimeter walls.
